TF-104G "38459" (US serial number 63-8459) at Luke AFB in July 1980

Date: Tuesday 14 July 1981
Time: day
Type: Lockheed TF-104G Starfighter
Owner/operator: 58 TFTW Luftwaffe
Registration: 63-8459
MSN: 5763
Fatalities: Fatalities: 0 / Occupants: 2
Aircraft damage: Written off (damaged beyond repair)
Location: Aquila, AZ - 🇺🇸 United States of America
Phase: Manoeuvring (airshow, firefighting, ag.ops.)
Nature: Military
Departure airport: Luke AFB, AZ
Destination airport: Luke AFB, AZ
Confidence Rating: Information is only available from news, social media or unofficial sources

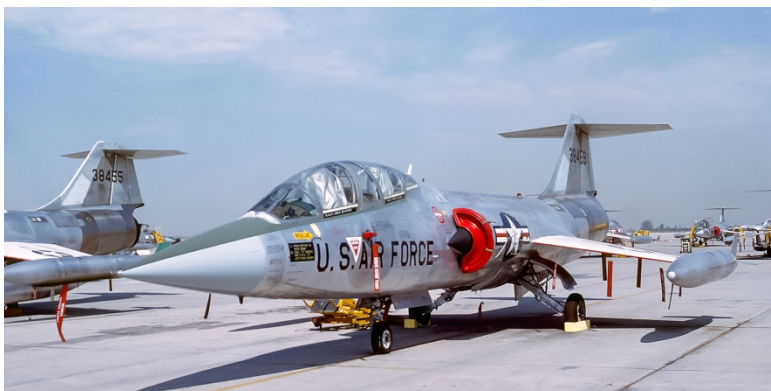
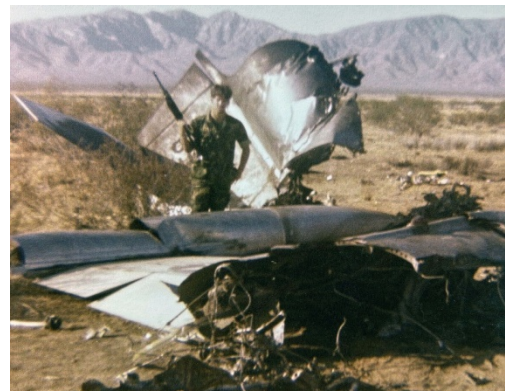
🇺🇸 operated by the 4510th CCTW at Luke AFB, Arizona (German shadow serial number 2761); coded 38459 in USAF Silver-finish color scheme; 2.792 flight hours in May 1977 crashed July 14, 1981 after engine failure due to a broken throttle control linkage (Electrical Fire), both crew ejected safely 3.417 flight hours; 69 TFTS, struck off charge order (AVA) July 14, 1981; crash site: near Aquila, 15 NM West of Wickenburg.

(shadow serial 27+61) This Starfighter, based at Luke AFB, crashed in Arizona after an engine-stall. Pilots USAF Capt. (IP) Chris R. Glaeser and 2nd Lt Ralph P. Dietl ejected safely. The aircraft was conducting a transition training sortie in the Gladden MOA, Arizona. During the initial entry for a loop, an RPM decrease was experienced with a corresponding loss of thrust. The instructor resumed control of the aircraft and recovered it to level flight. He followed the standard restart procedures but sadly with no success. In total he made 3 attempts. Both pilots ejected at 5000 ft MSL (3000 ft AGL). Aircraft was destroyed completely on impact and both pilots were fine with some small injuries. Investigation revealed: engine failure due to a broken throttle control linkage (Electrical Fire). The International F-104 Society owns a copy of the official accident report. Crash location: 33 57 23. 7N 113 19 20.1 W
